DOT/FAA/CT-84/10

Seat Experiments for the Full-Scale Transport Aircraft Controlled Impact Demonstration

Mark R. Cannon Richard E. Zimmermann

RMS Technologies, Inc./Simula Inc. Trevose, PA/Tempe, AZ

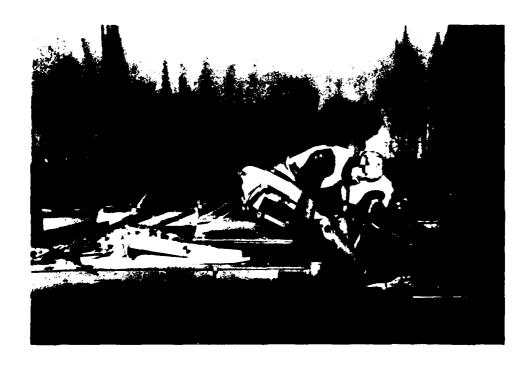
RESULTS OF FORWARD DYNAMIC TEST. Figure 53 shows the final position of the seat after being tested at 9 G with a 50-ft/sec velocity change. Note that the seat separated completely from the leg structure, and only the redundant tiedown straps (part of the test setup) kept it from leaving the test fixture. Failure points are labeled in figure 54. Arrow 1 indicates the window-side leg detached from the rear track fitting, arrow 2 indicates failure of the front and rear tube fittings on the window-side leg, and arrow 3 indicates a similar situation which occurred on the aisle-side leg.

Figure 53. Posttest standard Weber seat (Dynamic Test).

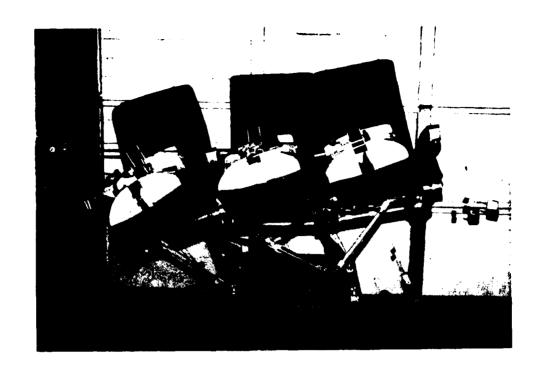
RESULTS OF LATERAL STATIC TEST. A lateral load was applied to the body blocks (figure 65) until the seat failed. This occurred at 7.8 G, when the front window-side leg pulled through the bolt attaching it to the track fitting. Figure 66 shows this failure, and figure 67 is the loading curve during the test. Further details of the seat's performance are in reference 40.

Figure 65. Posttest Weber MOD I seat (Lateral Test).

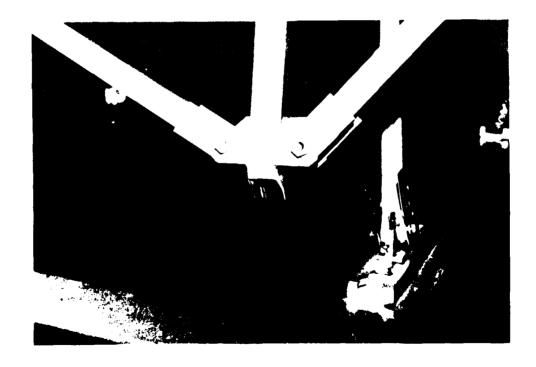
Figure 66. Failure point on Weber MOD I seat (Lateral Test).

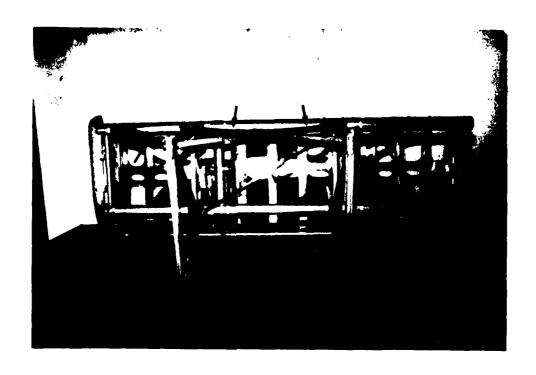
The modified seat is shown in figures 73 through 76. Arrows in figure 75 indicate diagonal braces and straps used to reinforce the seat under lateral loads. Figure 76 shows the energy absorbers and modified seat pan.

Figure 75. Weber MOD II seat lateral bracing - bottom view.

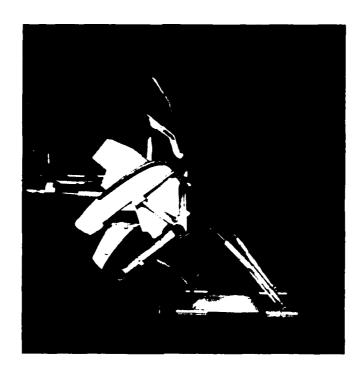
Figure 78. Posttest Weber MOD II seat (Forward Static Test).

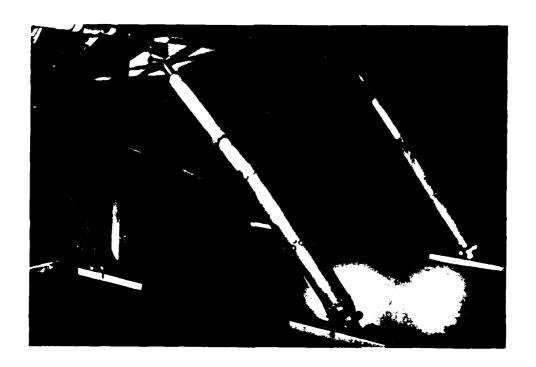
Figure 79. Location of energy absorber failure on the Weber MOD II seat (Forward Static Test).

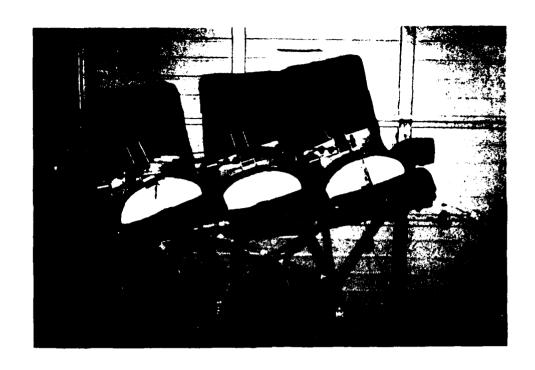
RESULTS OF LATERAL STATIC TEST. The lateral load applied by the body blocks on the seat caused it to fail at 10.4 G. The failure occurred when the bolt at the bottom of the front window-side leg pulled through the track fitting. Figure 81 is an overall posttest view, and figure 82 is a view of the track fitting failure. A production design of this fitting would include a boss which would prevent the shear failure. However, the structure did meet the design criteria with the unmodified fitting. The load versus lateral displacement curve is in figure 83.

Figure 81. Posttest Weber MOD II seat (Lateral Test).

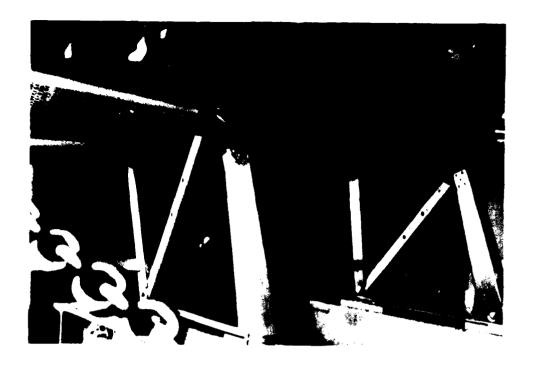
Figure 93. Posttest failed leg fitting on standard UOP seat (Forward Static Test).

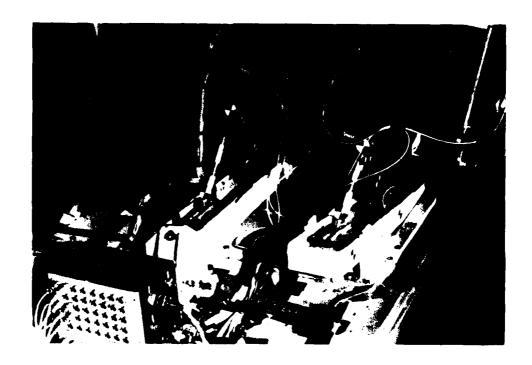
The posttest view in figure 84 shows that the dummies were retained in their seat positions, and a rear view in figure 85 indicates that the window-side energy absorber stroked but the aisle-side energy absorber did not. Test data show that the window-side energy absorber experienced an average force of 5370 lb which caused it to stroke 3.0 in. The aisle-side energy absorber was subjected to only 3900 lb, which is less than the static design stroking load of 4700 lb. (Dynamic stroking loads are higher than static stroking loads.)

Figure 85. Posttest rear leg energy absorbers of the Weber MOD II seat (Dynamic Test).

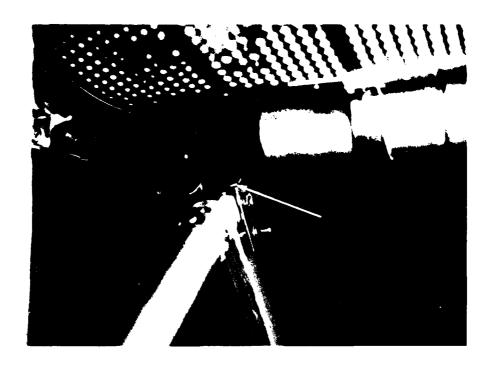
Figure 107. Posttest aisle-side rear leg fitting of UOP MOD I seat (Forward Static Test).

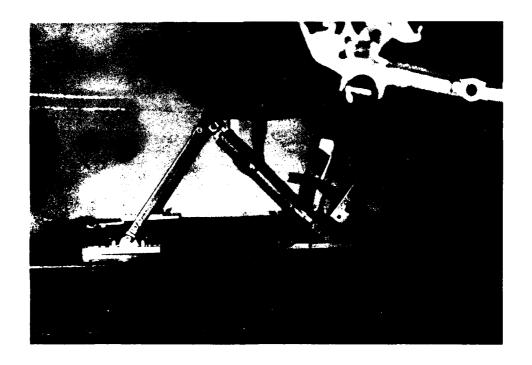
Figure 108. Posttest window-side energy absorber of UOP MOD I seat (Forward Static Test).

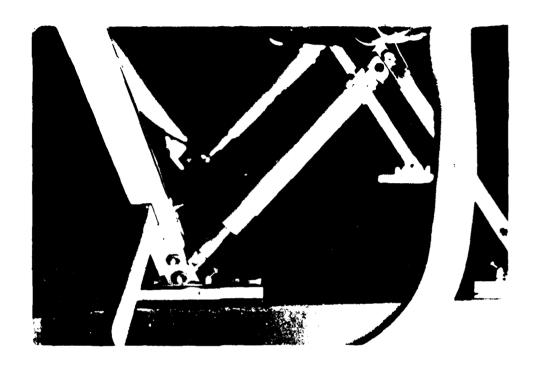
Figure 109. Posttest aisle-side energy absorber on UOP MOD I seat (Forward Static Test).

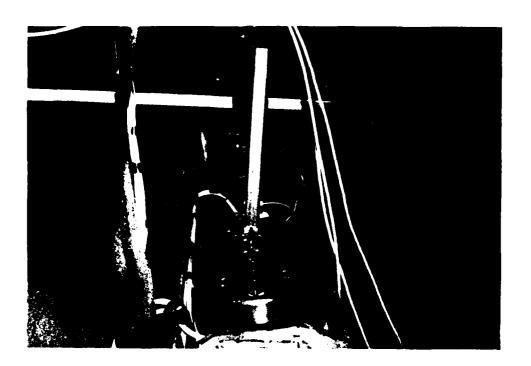
Figure 112. Pretest window-side rear leg of UOP MOD I seat after 10-degree track roll (Dynamic Test).

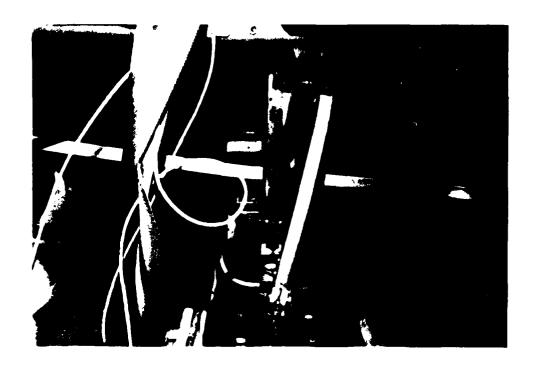
Figure 113. Pretest aisle-side rear leg of UOP MOD I seat after 10-degree track pitch (Dynamic Test).

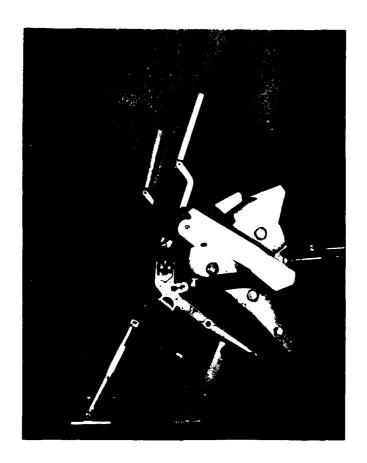
Figure 122. Posttest UOP MOD II seat (Forward Static Test).

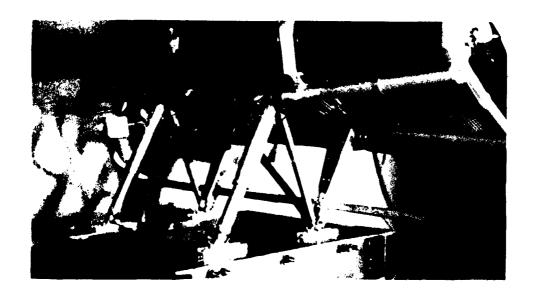
Figure 123. Posttest stroked rear leg energy absorbers of UOP MOD II seat (Forward Static Test).

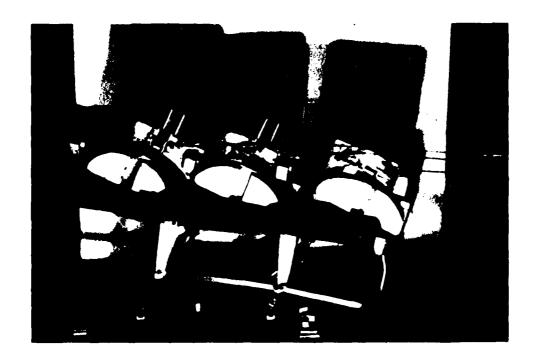
Figure 125. Posttest UOP MOD II seat (Lateral Test).

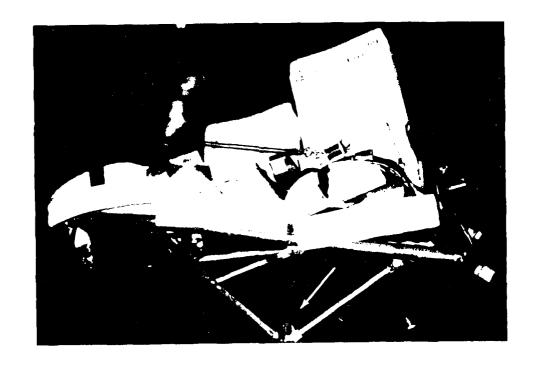
Figure 149. Posttest front view of Weberlite MOD seat (Lateral Test).

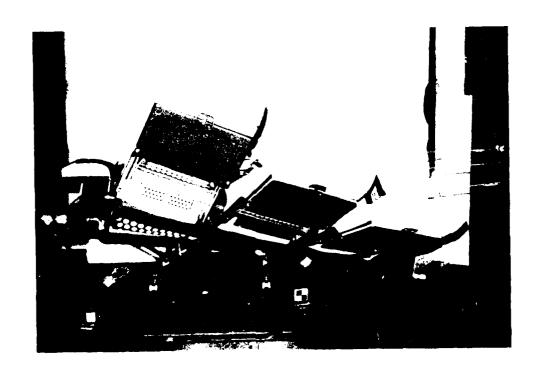
Figure 150. Posttest rear view of Weberlite MOD seat (Lateral Test).

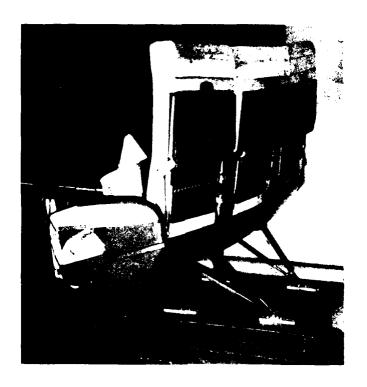
Figure 147. Posttest Weberlite MOD seat (Forward Static Test).

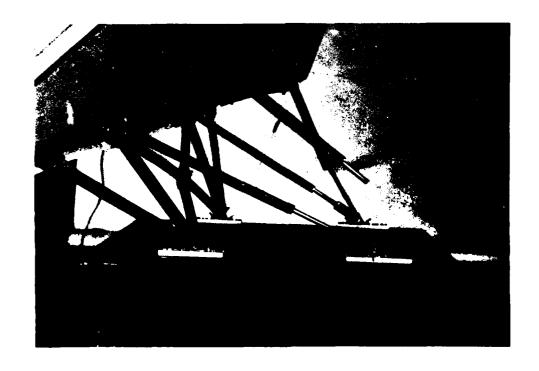
Figure 148. Posttest failed window-side leg energy absorber of Weberlite MOD seat (Forward Static Test).

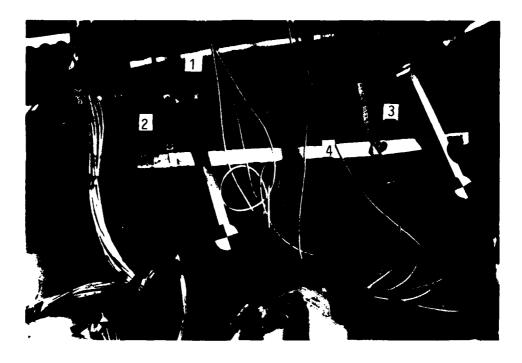
Figure 138. Failure points of standard Weberlite seat (Dynamic Test).

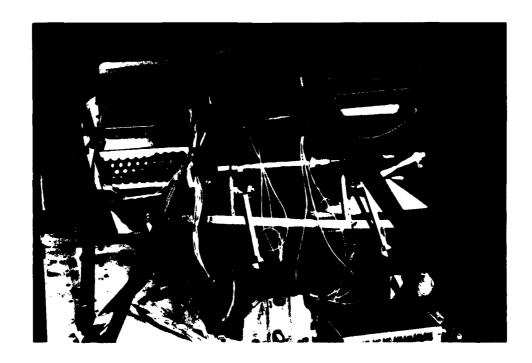
Figure 137. Posttest rear view of standard Weberlite seat (Dynamic Test).

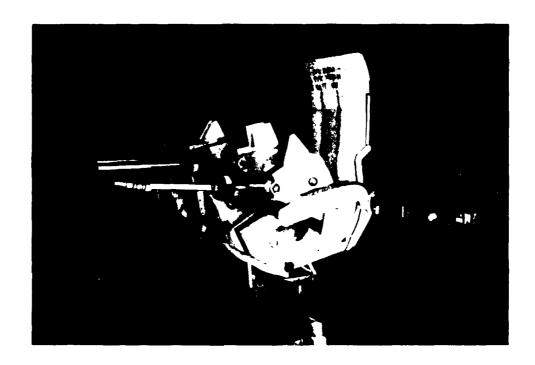
Figure 134. Posttest standard Weberlite seat (Forward Static Test).

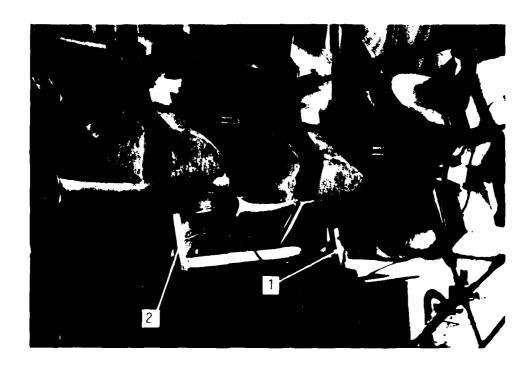
Figure 135. Failure points of standard Weberlite seat (Forward Static Test).

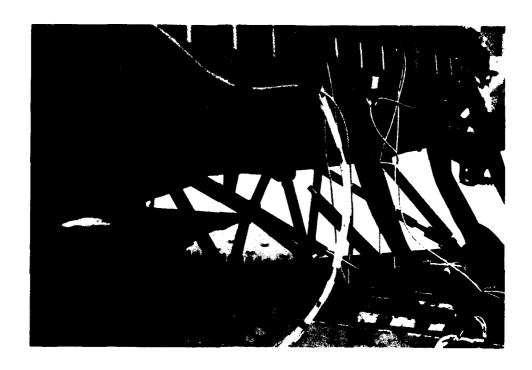
Figure 153. Posttest failed rear leg and diagonal energy absorber of Weberlite MOD seat (Dynamic Test).

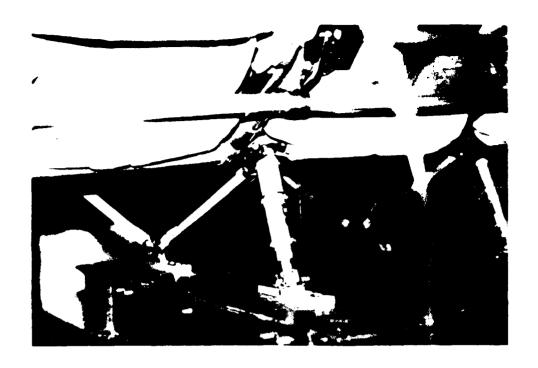
A problem occurred which did not influence the results of the test: the window-side energy absorber pushed into the front tube (figure 167). This caused the diagonal brace to begin peeling open the tube bracket (figure 168). The portion of the tube that collapsed was reinforced on the seat used for the dynamic test.

Figure 167. Posttest damage to front tube of Weber aft-facing MOD seat (Forward Static Test).

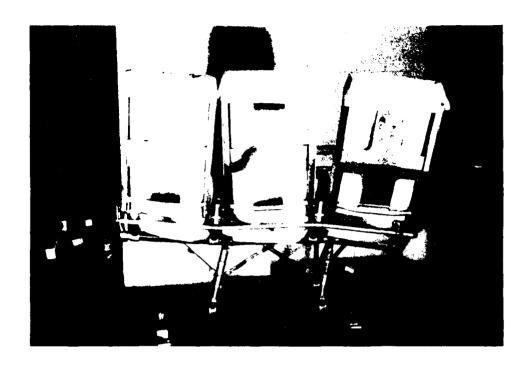
Figure 168. Posttest damage to front tube bracket of Weber aft-facing MOD seat (Forward Static Test).

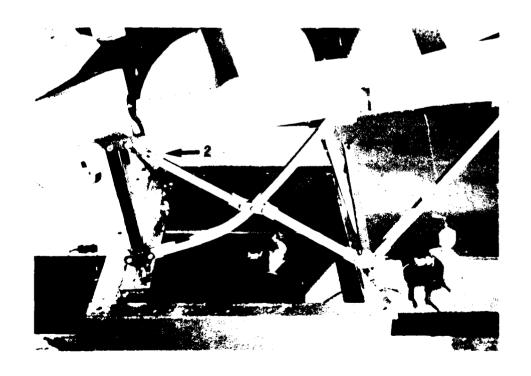
RESULTS OF LATERAL STATIC TEST. A lateral test was performed on the seat, as is illustrated in figure 169. The first failure occurred at 3.7 G, when the bolt connecting the rear window-side leg to the rear tube fitting pulled through the leg, as is indicated by arrow 1 in figure 170. Since ultimate failure of the complete structure had not occurred, the test was continued until, at 9.1 G, the bolt connecting the rear tube aisle-side fitting to the diagonal pulled through the diagonal, as is indicated by arrow 2. The loading curve during the test is shown in figure 171. A further description of the seat's performance is in reference 48.

Figure 170. Failure points of Weber aft-facing MOD seat (Lateral Test).
